Attachment 1 – Updated DMG Paint Remediation Plan

**Update to the Kittiwake Letter of Application from the Cayman Islands
Department of Transportation, MARAD, dated November 5th, 2006
Updated January 23, 2008**

This document is an update to the Kittiwake Reefing Plan and application to MARAD for the donation/transfer of a ship for artificial reefing purposes to the Cayman Islands.

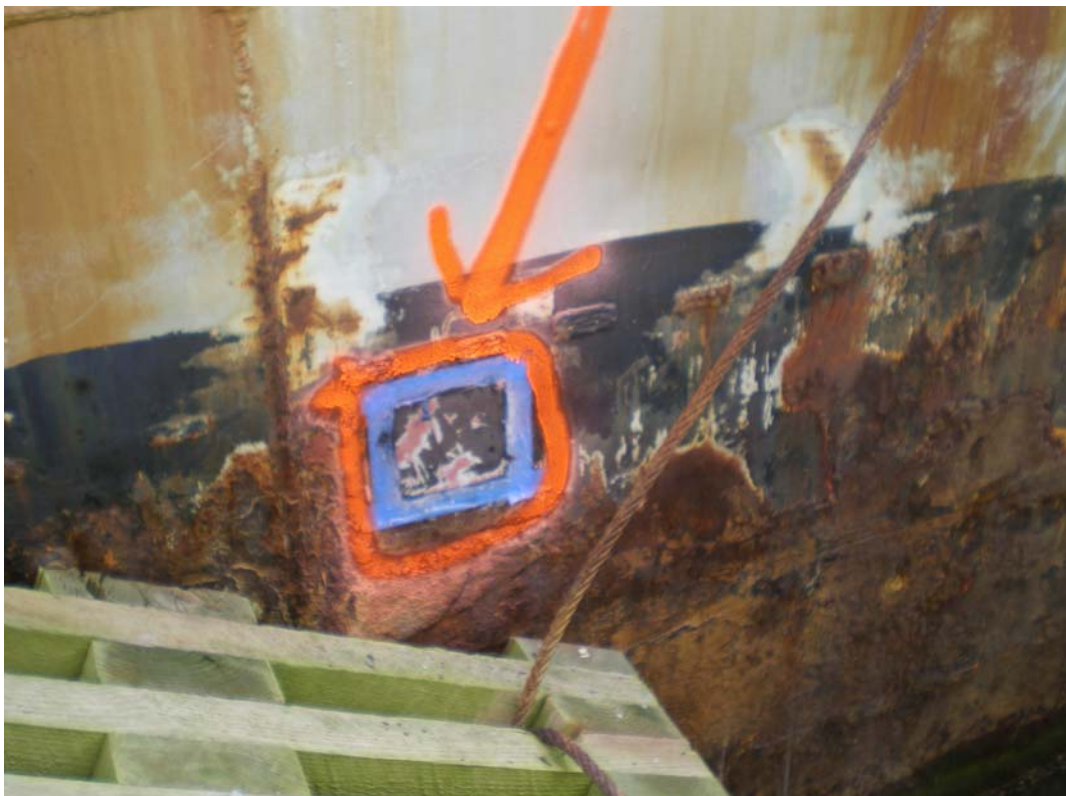
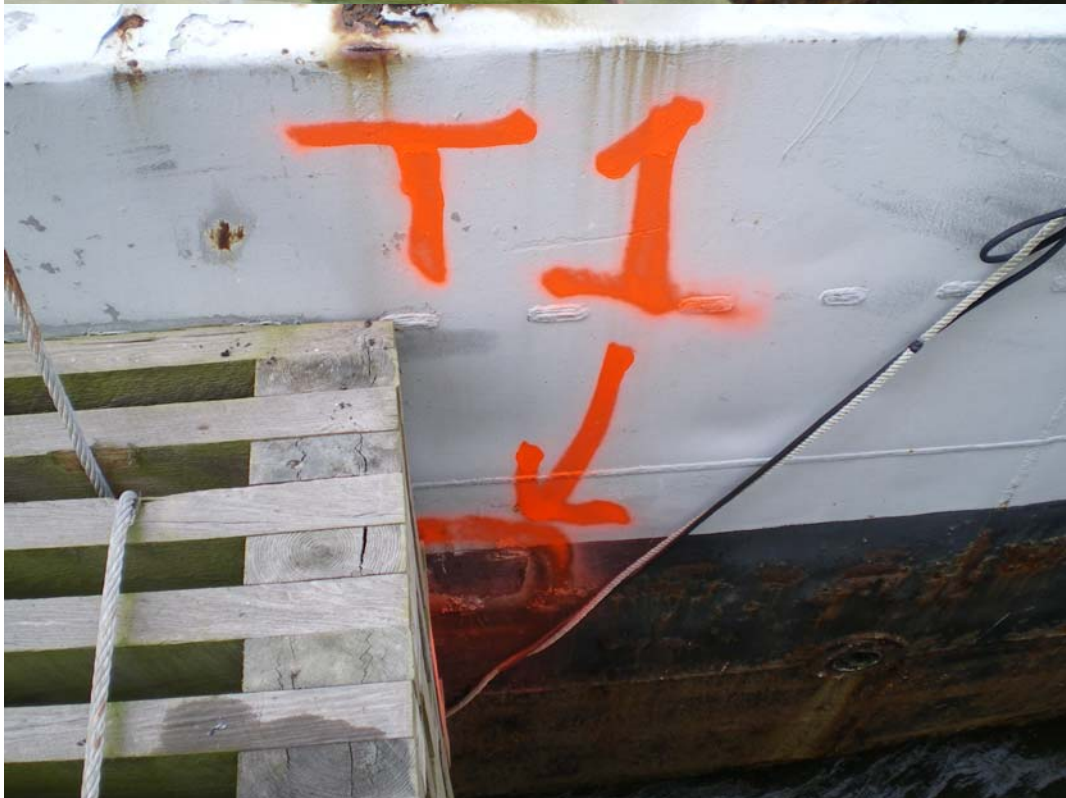
Kittiwake – TBT Paint samples on the anti-fouling paint Sept 2007. The blue pieces of tape are to mark where original samples were. The sample site was extended for the two confirmatory samples and specifically tested for TBTs, in addition to PCBs.

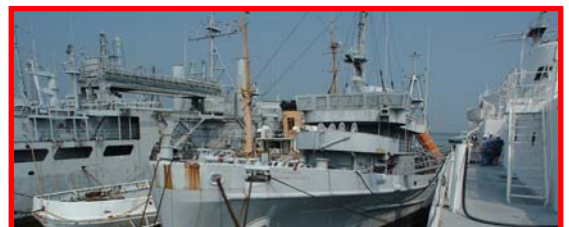
Ex-USS Kittiwake 251' Sub Rescue ASR-13:

- Chanticleer Class Submarine Rescue Vessel
- Displacement: 2,045 tons (full load)
- Length: 251'4"
- Beam: 42' Draft: 16'
- Speed: 14.5 knots (max); 10 knots (econ)
- Armament: 2 3"/50 DP, 8 20mm, 4 DC tracks
- Complement:
- Diesel-electric engines, single screw, 3,000 h.p.
- Built at Moore, Savannah and commissioned 1944
